SCANNING ELECTRON MICROSCOPY (SEM)

Machine Maintenance and Failure Diagnostics

Caterpillar Engine Cam Shaft Sleeve Bearing Failure

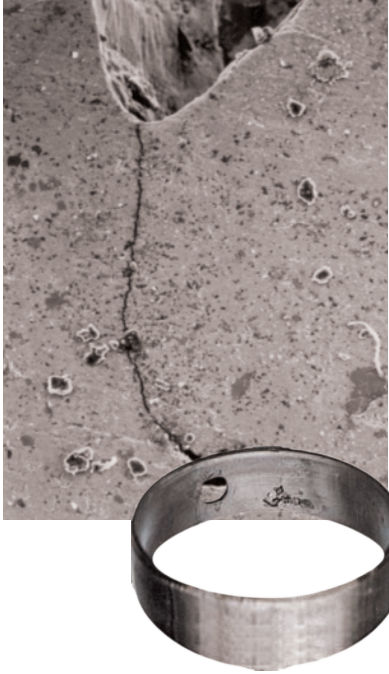
The camshaft sleeve bearings were found to be severely pitted. Large particles broke away and a costly failure occurred.

Cavitation erosion caused by the formation of oil vapour bubbles in low pressure areas and the collapse of those bubbles in higher pressure areas.

Confirmed that as the initial pitting and material removal continued due to cavitation erosion, larger scale pits/pores developed. This caused a deeper penetration of the vapour bubbles, which resulted in further fracture creation and propagation as well as the large scale removal of bearing material.

This type of failure can occur on diesel engine cam shaft sleeve bearings under high speed and/or high load conditions.

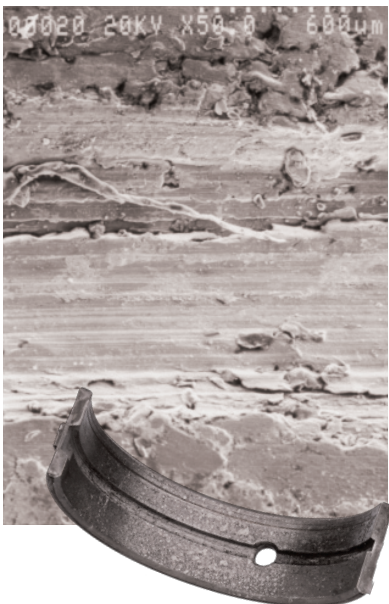
Caterpillar Diesel Engine Bearing Failure

The crankshaft bearings were found to be in various states of abrasion.

Deep scoring and discoloration suggested that high levels of dirt had either severely scratched or become embedded into the soft overlay of the bearings.

Confirmed deep scoring on the bearing surface combined with foreign material embedded in the bearing surface at random locations. These foreign materials are irregular in shape and showed different colour variations in response to electron bombardment.

These colour variations indicated foreign material of different composition and type.

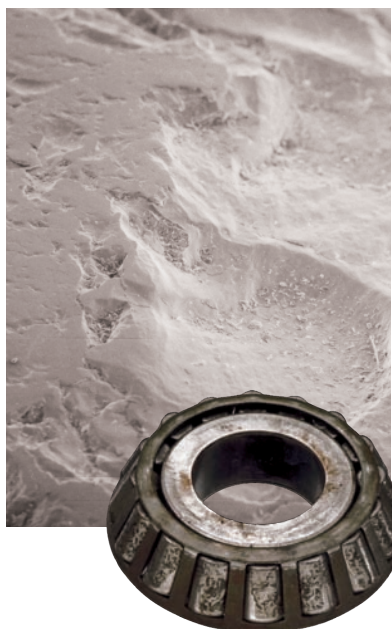
Tapered Roller Bearing Failure, Final Drive Application

Discoloration and severe spalling of the bearing.

The condition suggested fatigue spalling with possible rust development. However, the oil analyzed for water content and results were negative.

Confirmed that the severe spalling of the bearing was not due to fatigue. This was evident by the rather smooth surfaces of the damaged areas. Normally, fatigue spalling causes sharp and/or jagged edges to the spalls.

The more smooth spalls that developed indicate the occurrence of strong acids which resulted from excessive water in the oil that had evaporated during a period of hot shutdown just prior to equipment storage. The bearing cones showed similar spalling conditions, though only on the inner race surfaces that were above the surface of the oil.

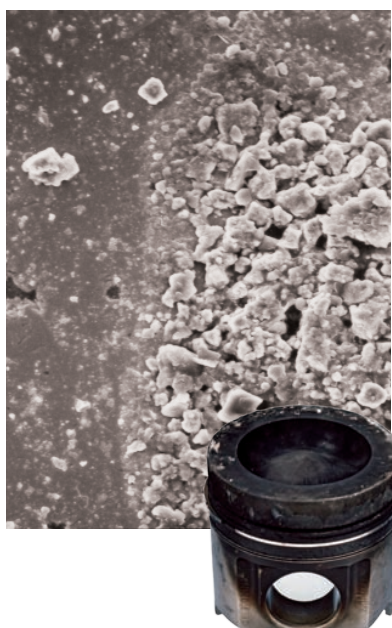
Caterpillar Diesel Engine Piston, Ring and Liner Failure

The Piston failure resulted in a scored cylinder liner and ring sticking condition.

The owner had been using an after-market oil conditioner to reduce friction and the engine manufacturer refused warranty on that basis.

Confirmed large deposits of carbon and soot material. Further analysis of these carbon/soot deposits using X-ray Energy Spectroscopy showed the elements; iron, sodium, magnesium, phosphorus, sulphur, calcium and zinc. The high level of sulphur indicated unburned fuel and this supported an initial suspicion that a fuel leak had occurred, washing past the piston ring area. This condition accounted for the ring sticking and eventual piston failure.

Since the remaining elements are indicative of the normal additives found in diesel engine oils, there was no evidence that any foreign or incompatible after-market additives had been the cause of failure
